LMI REPAIR DEPARTMENT TIPS

December 1991

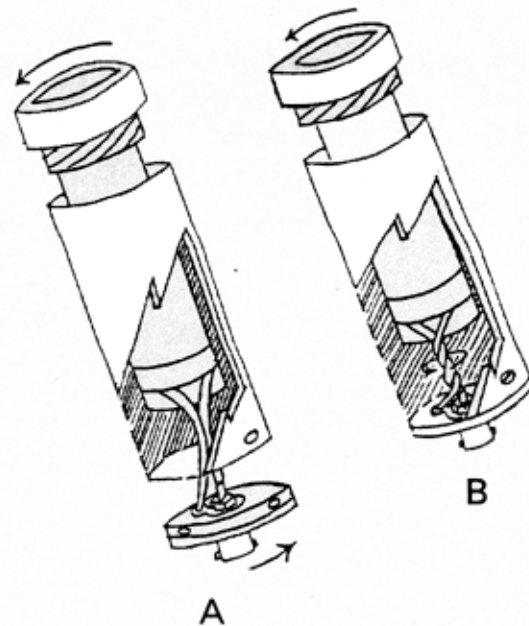
A problem that customers sometime experience is broken detector wires. The LMI models 43-2, 44-1, 44-3, and 44-21 are the most common detectors we have returned to us with this problem. The wires are often snapped when the end window cap is unscrewed to replace the mylar window or when the optical seal is checked.

The probe on the left (A) show how the window end cap should be removed. The probe on the right (B) shows how the wires are twisted if end cap is removed improperly. If you have questions about this or any other instrument problem, please give our Repair Department a call at 800/622-0828

The solution to this problem is simply to undo the connector end of the detector before unscrewing the window end of the detector. This will allow the internal parts to spin freely, thus relieving any tension on the PMT wires.
